Test Report No.: CANEC24021333715 **Date**: Oct 09, 2024 Page 1 of 4

Sample Name: Semiconductor device

Model No.: SOT-23

Halogen

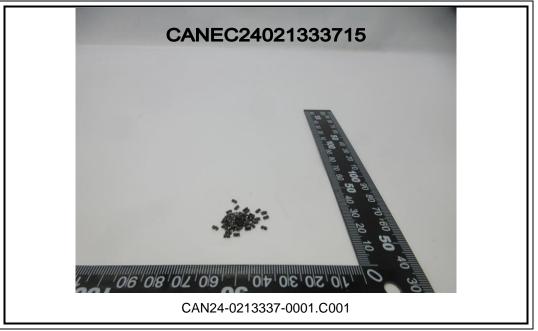
Sample Photo:

SN ID	Sample No.	SGS Sample ID	Description
SN1	A1	CAN24-0213337-0001.C001	Black body with silvery metal
